Manhole Inspection Summary

Manhole # S25A__027MH

Insp Date: **8/20/07 11:10 AM**

Location Address: **1212 HARLEM AVE**

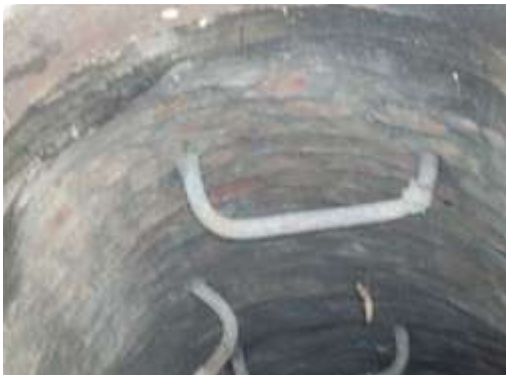
Defect 2

Infiltration: ☐ None ☐ Joint ☐ Cracks ☐ Mortar ☐ Roots ☒ **Wall**

CHIMNEY INFILTRATION

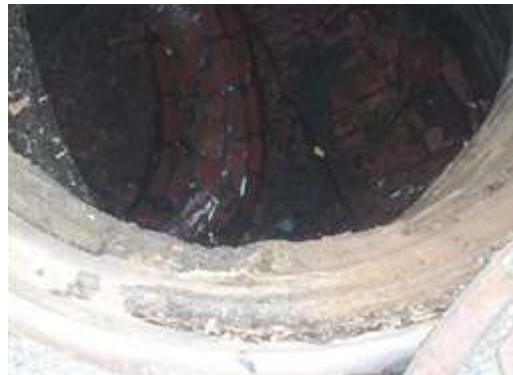
Defect 1

Offset: **1** (in.)

FRAME OFFSET

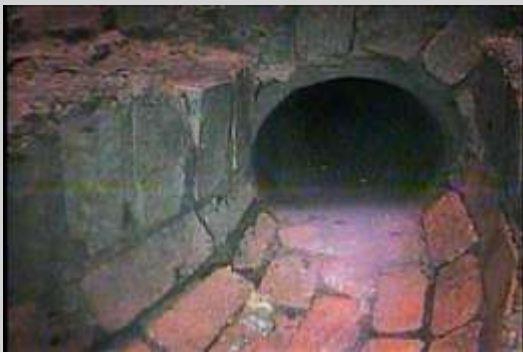
12 O'Clock Outflow

8 in. Circular Gravity Sewer
Pipe Out @ 12 O'Clock

Pipe Height: **8.4** (in.) Rod and Bar (Angled)
Pipe Material: **Clay** ☐ Pipe Lined
Invert Depth: **9.62** (ft.) Flow Characteristics: **Slow**
Deposits: ☒ None ☐ Mud ☐ Sludge ☐ Debris ☐ Grease
Silt Depth: (in.) Deposits Extent:
Infiltration: **None** Pipe Seal Cond: **Sound**

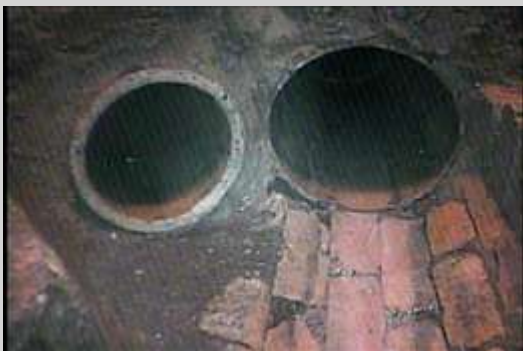
8 O'Clock Inflow

6 in. Circular Gravity Sewer
Pipe In @ 8 O'Clock

Pipe Height: **6** (in.) Rod and Bar (Angled)
Pipe Material: **Clay** ☐ Pipe Lined
Invert Depth: **8.98** (ft.) Flow Characteristics: **None**
Deposits: ☒ None ☐ Mud ☐ Sludge ☐ Debris ☐ Grease
Silt Depth: (in.) Deposits Extent:
Infiltration: **None** Pipe Seal Cond: **Sound**

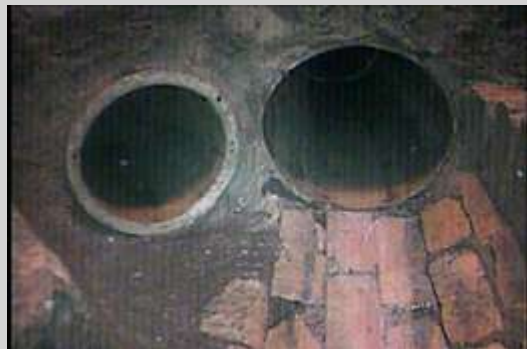
9 O'Clock Inflow

8 in. Circular Gravity Sewer
Pipe In @ 9 O'Clock

Pipe Height: **8.4** (in.) Rod and Bar (Angled)

Infiltration: **None** Pipe Seal Cond: **Sound**
